# City of Lake City

## City Hall Structural Assessment

#200-08521-18002  
September 6, 2018

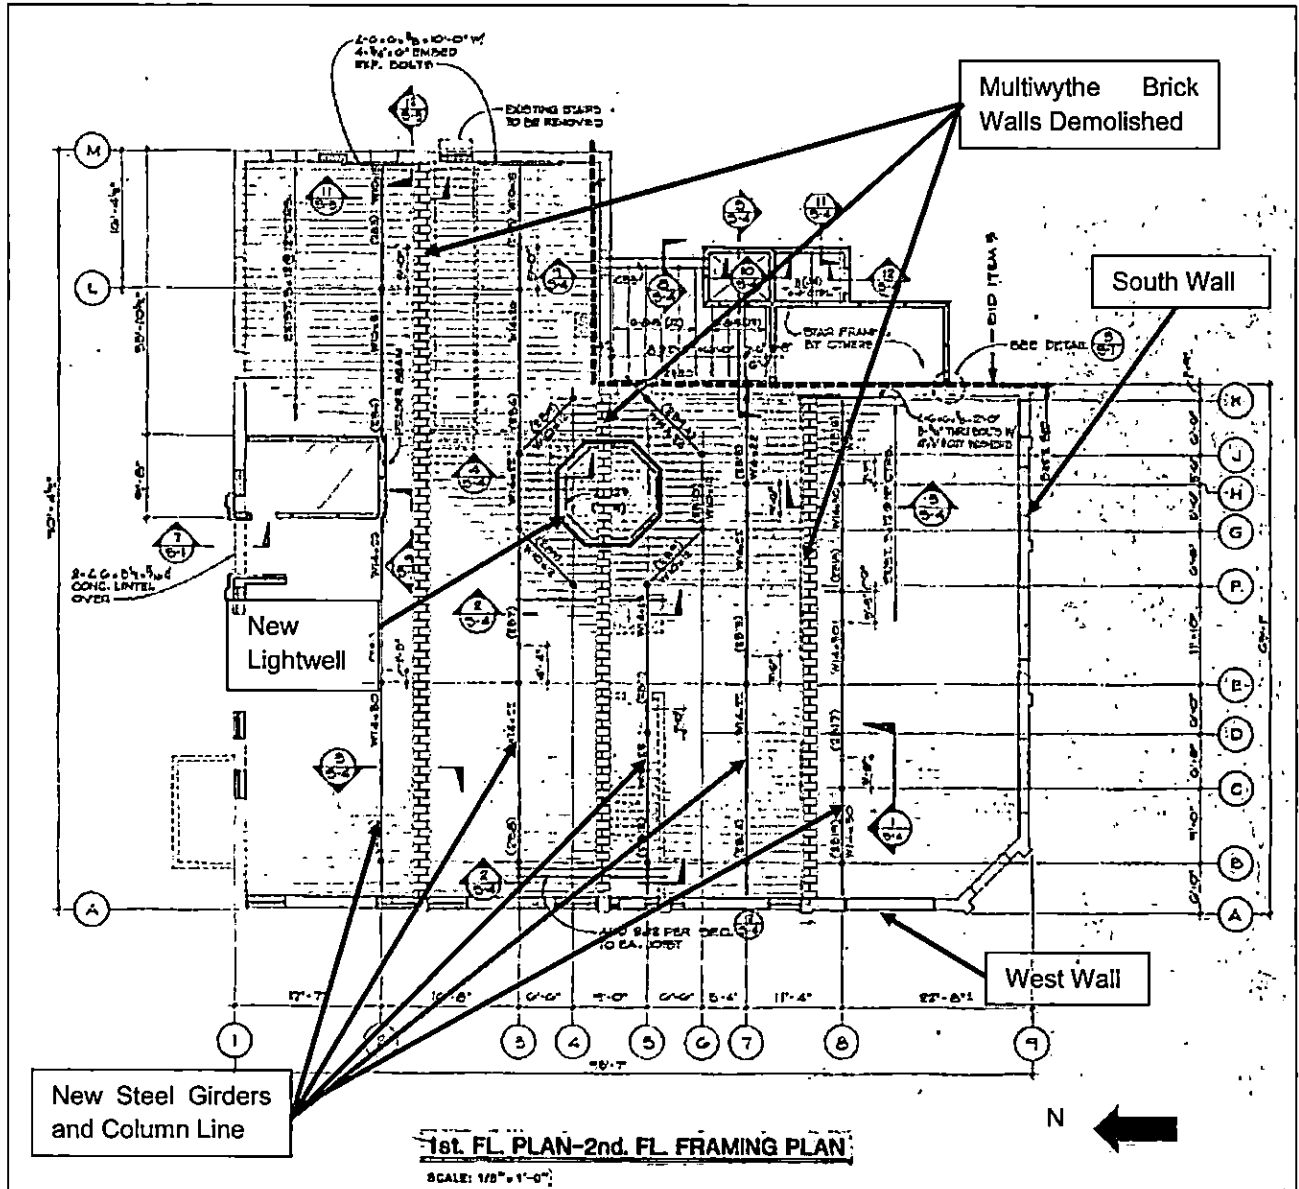
Figure 2: 1985 Renovation - Demolition Plan

When the building was originally constructed, there were three interior load bearing multiwythe brick walls that aligned with the pilasters on the west face of the building. However, the 1985 renovation removed these load bearing walls and replaced them with five new steel girder lines, see **Figure 2**. The member sizes and connection detailing for this steel framing appears to be just for gravity loads and does not indicate that they were designed as moment frames to resist lateral loads. So, there is no indication that the new steel framing is meant to replace the lateral stability and strength of the original brick walls. Furthermore, the new steel girders are not connected to the east and west brick walls, so no bracing support is provided by them.

The floor and roof decking were assumed to act as flexible diaphragms that transfer laterally applied wind loads based on tributary area and not stiffness. Usually, flexible diaphragms only transfer wind loads to walls that are parallel to the direction of the applied wind load. For wind loads in the E-W direction the lines of lateral resistance are exterior brick walls along grids 1, 4.4, and 9, as shown in *Figure 2*. Wind loads in the N-S direction are transferred to walls along grids A, K, and M.

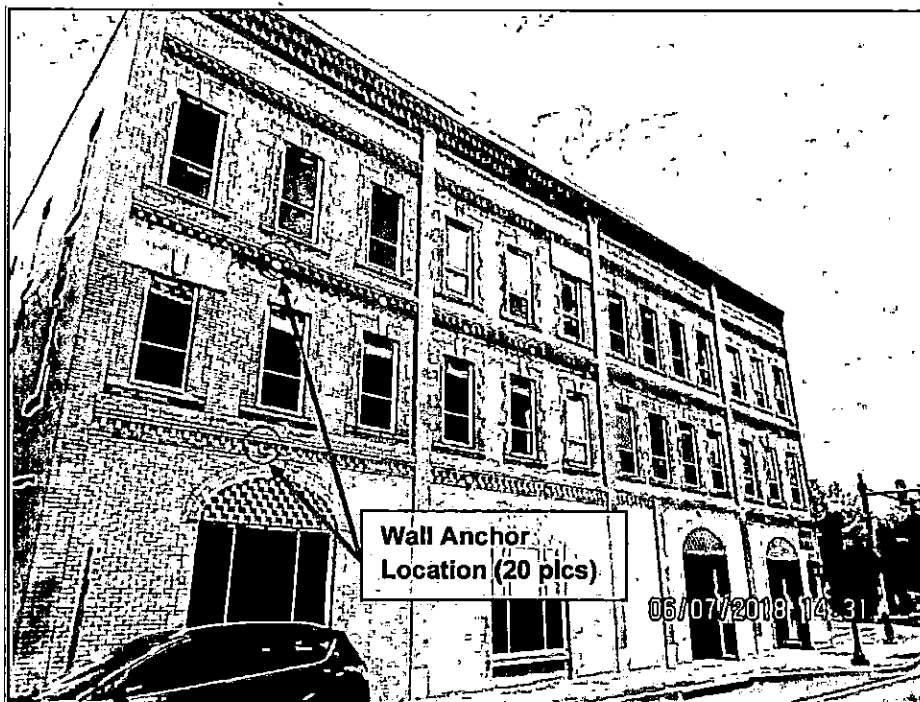
Older buildings like this do not typically have significant lateral load path connections from the floor deck and framing to the perimeter of the building. It was confirmed onsite that there is not an identifiable load path for in and out-of-plane loads from the east and west walls to the floor diaphragm. The timber joists bearing on the north and south walls do offer some bracing due to the friction developed by the mortar and timber interface in the wall pocket. We also discovered some tie-back rods/anchors were installed to help stabilize the west wall, but it is unknown when these retrofit anchors were installed. **Photo 4** shows a typical anchor and **Photo 5** shows an example where an anchor does not support the wall as intended due to missing blocking. There are 20 of these wall anchors installed on the west wall of the building, as shown in **Photo 6**.

*Photo 6: West Facade Anchor Locations*
