# City of Lake City

## City Hall Structural Assessment

#200-08521-18002  
September 6, 2018

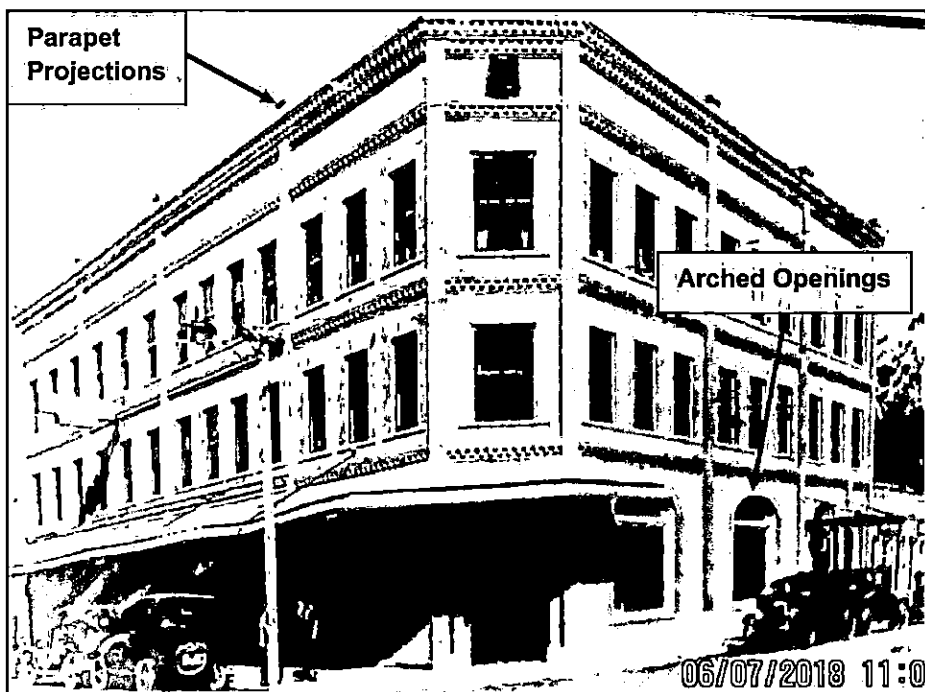
*Photo 1: Original Building*

The City purchased the building around 2005 and currently occupies all three floors. As-built drawings were not available to review for original construction details and building age. It is a three-story building, approximately 23,000 ft<sup>2</sup> with load-bearing multi-wythe brick walls, timber floors, and timber roof framing. An engraved stone on the building façade and historical pictures in the building indicate it was built circa 1911 (See *Photo 1*).

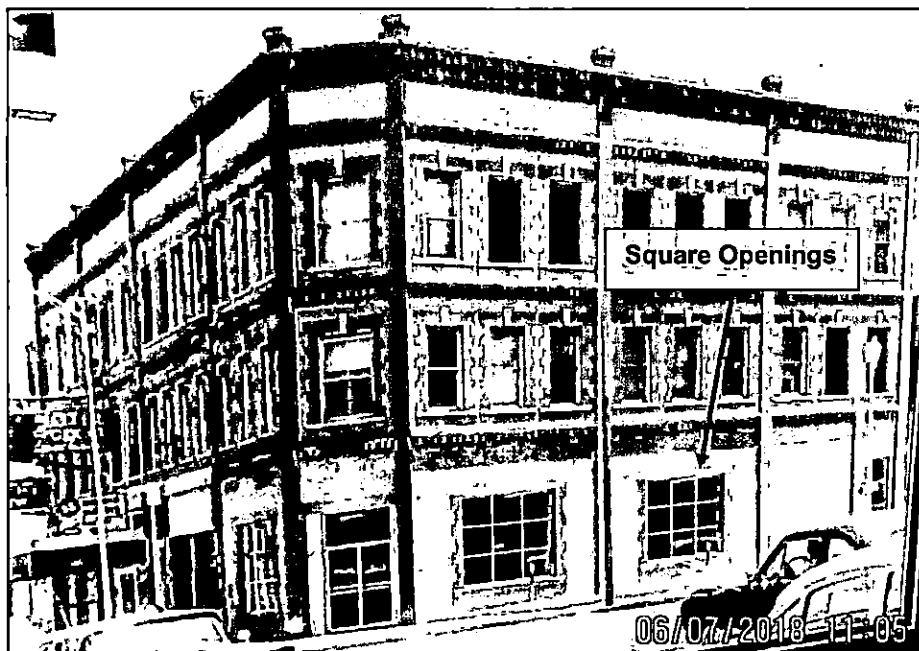
*Photo 2: Building with Modifications*

The building was originally constructed as a bank and hotel but has undergone many different renovations and uses throughout its lifespan as noticed in *Photo 2* and *Photo 3*. Most of the changes to the brick façade have been made along the first floor. The original arch shaped openings have since been restored, but the current condition varies from the original in that there is a recessed corridor and entry along the southwest corner of the building. Record drawings were provided for a major renovation and addition project that was performed around 1985. As part of that renovation three interior, load-bearing, multiwythe brick walls were removed and replaced with steel columns and beams. This is the focus of this study and report. The 1985 renovation also included a three-story reinforced cmu addition on east side of the building for a stairwell and elevator (See *Figure 1*).
