Asbestos Survey

**Old City Water Plant
298 S.E. Clements Place
Lake City, Florida**

ATLAS Project No.: 2984001

Date: November 15, 2010

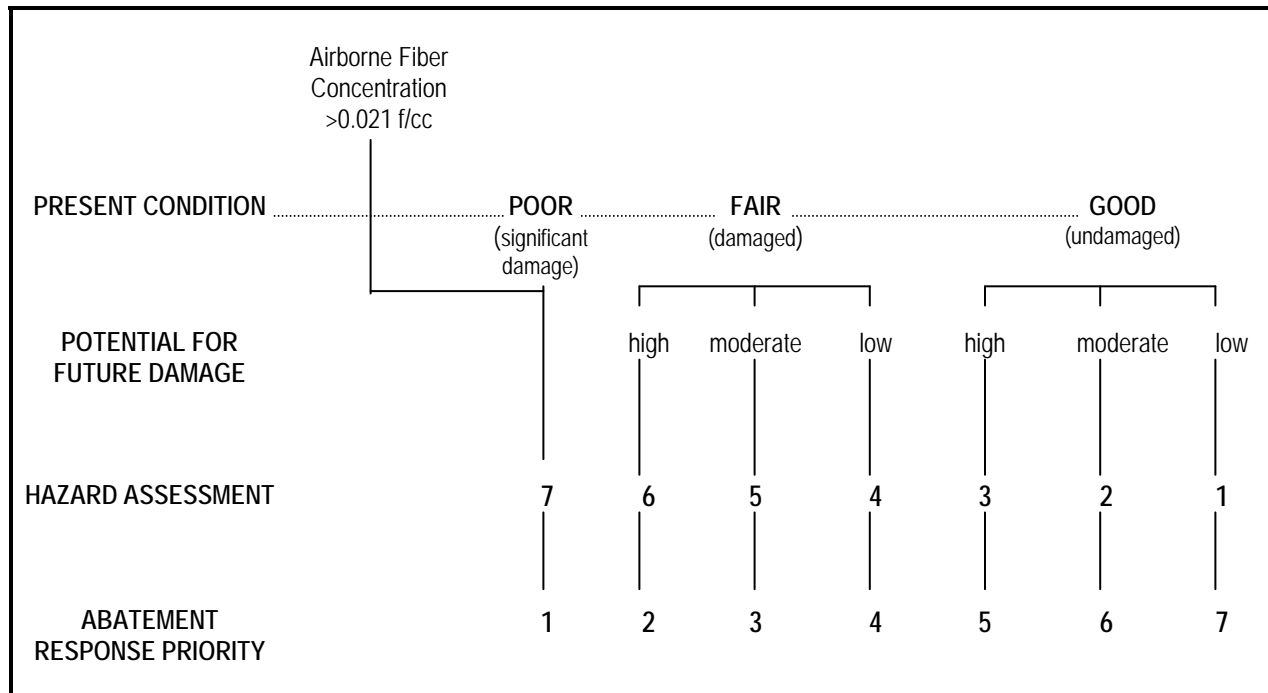
The hazard ranking for each functional space (homogeneous material) will be a number ranging from "1" to "7". A hazard ranking of "1" indicates that the material is in "good" condition with a "low" potential for future damage. This material would have a low abatement response priority. A hazard ranking of "5" would indicate that the material is in "fair" condition with a "moderate" potential for future damage. This material would subsequently have a higher priority for a response action. A ranking of "7" would indicate the material is in "poor" condition and therefore would have the highest priority for an abatement response action.

All identified asbestos-containing materials were assessed for potential asbestos exposure hazards. The potential asbestos exposure hazards are based on the condition of the material and its potential for disturbance. The hazard assessment and the abatement response priority are determined by utilizing the Asbestos Hazard Assessment Decision Tree outlined below.

Table II-B in Section IIB presents the hazard assessment and the abatement response priority ranking for each asbestos-containing material as determined by the Hazard Assessment Decision Tree.
